A Case Study on Causes of Scale Formation- Induced Damage in Boiler Tubes

Abstract

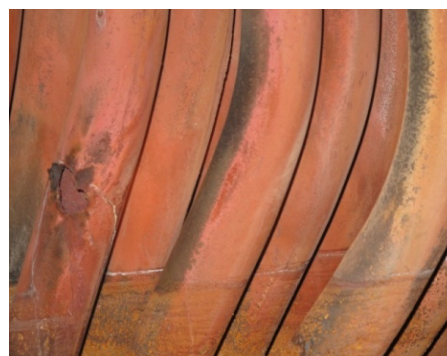
Inspection of boiler showed that one of boiler tubes has been damaged approximately 30 cm upper than its bottom, caused by corrosion of inner surface (Figure 1).

Figure 1: Tube damage

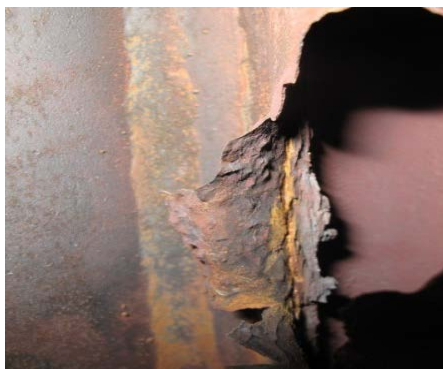
Inner surface corrosion induced deterioration and thinning of this tube is shown in figure 2. It is clear that the corrosion reduced the tube thickness. Then this tube eventually ruptured because of lack in pressure strength.

Figure 2: Tube damage at higher resolution

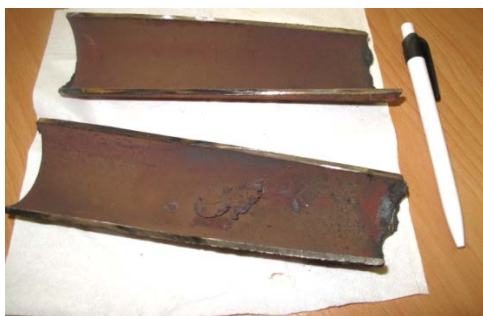
As it is seen in figure 3, gradual and zonal scale formation and corrosion is observed in tube side, which is exposed to fire. These are hard, sticky and dark brown colored scales. The amount of these scales is considerably high in area of 30-50 cm over mud drum, which is exposed to hot gases. The occurrence of corrosion is obvious under these scales.

Figure 3: Unholed tubes

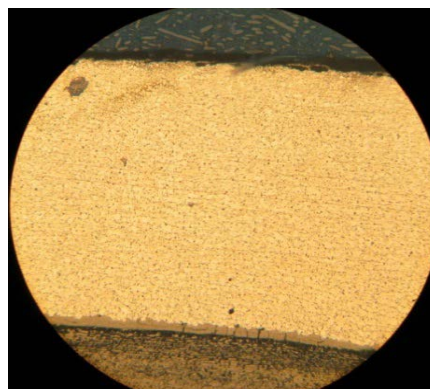
In order to investigate the morphology of scales and changes in microstructure of tube surface in corroded area, sample with hard sticky scale was selected and subjected to optical and scanning electron microscopy after appropriate preparation. SEM study presents that the outer surface of tube has no protective oxide coating, but the inner surface possesses a thin oxide layer and a porous scale (Fig. 4). As is depicted in fig.4, several cracks are present in oxide layer, which may lead to lack of adhesion of this layer to tube surface and hence, the lack of protection against corrosion. Because of porosity of scales and cracked character of oxide layer, corrosives diffuse into these layers and facilitate the surface corrosion of tube surface.

Figure 4: Cracked porous oxide layer of scale on inner tube surface

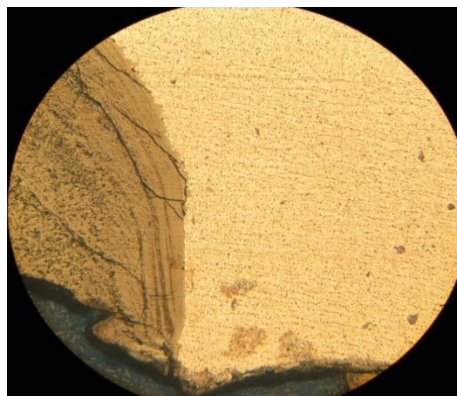
The presence of a protecting layer of scales in the inner surface of tube is shown in figure 5, which has been taken from zone located approximately 10 cm away from damaged zone. This layer possesses several cracks. Corrosives in association with water diffuse into layer of scales through these cracks. This phenomenon promotes the zonal corrosion.

Figure 5: Numerous cracks and diffusion of corrosives into the protective layer of scale on inner tube surface

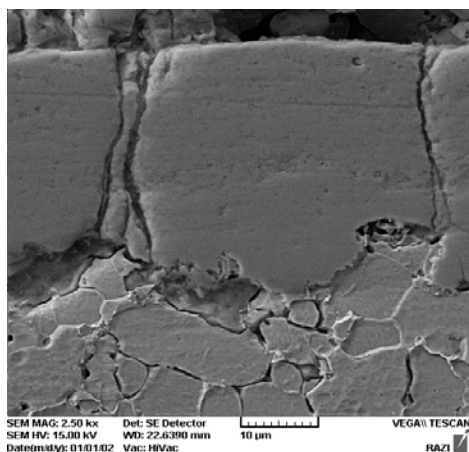
Fig 6 shows the tube cross section in damaged area. It is observed that oxide layer is cracked in several zones. As it was mentioned

earlier, the presence of these cracks facilitates the diffusion of corrosives into the surface of tube surface.

Figure 6: Corrosion initiation at the interface of protective layer and tube surface at the end of protective layer

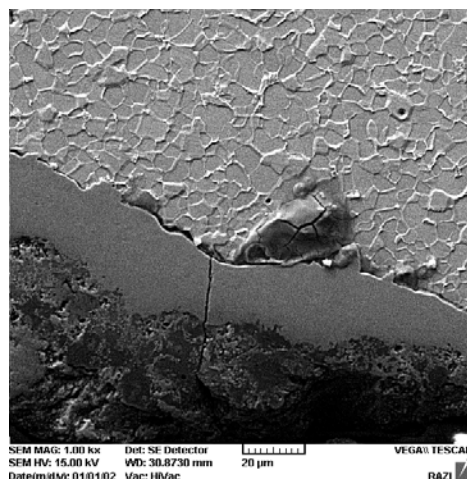
The onset of corrosion at the interface of protecting layer and surface of tube surface is shown with higher magnification in figure 7. It is clear that the corrosion initiates at the crack tips of protective layer, which act as directing channels for corrosives to the tube surfaces. As it is shown in figures 6 and 7, diffusion of

corrosives from inner surface of tubes through these cracks to interface of oxide layer and tube surface causes corrosion.

Figure 7: Tube cross section of the tube and crack in damaged zone

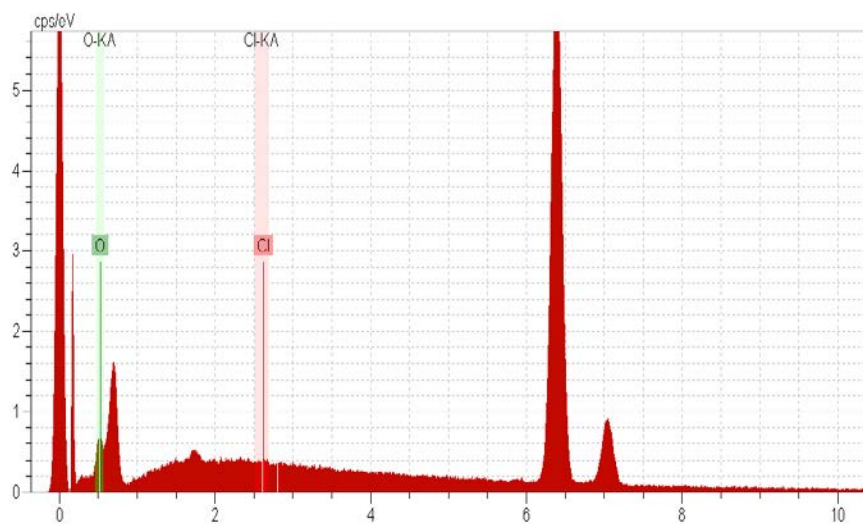
Chlorine map and corrosion germination under protecting layer is depicted in figure 8. This map clearly suggests chlorine ions aggregation in crack tips and interface between metal and oxide layer which causes corrosion germination in this zone.

Figure 8: Map of elemental chlorine and oxygen

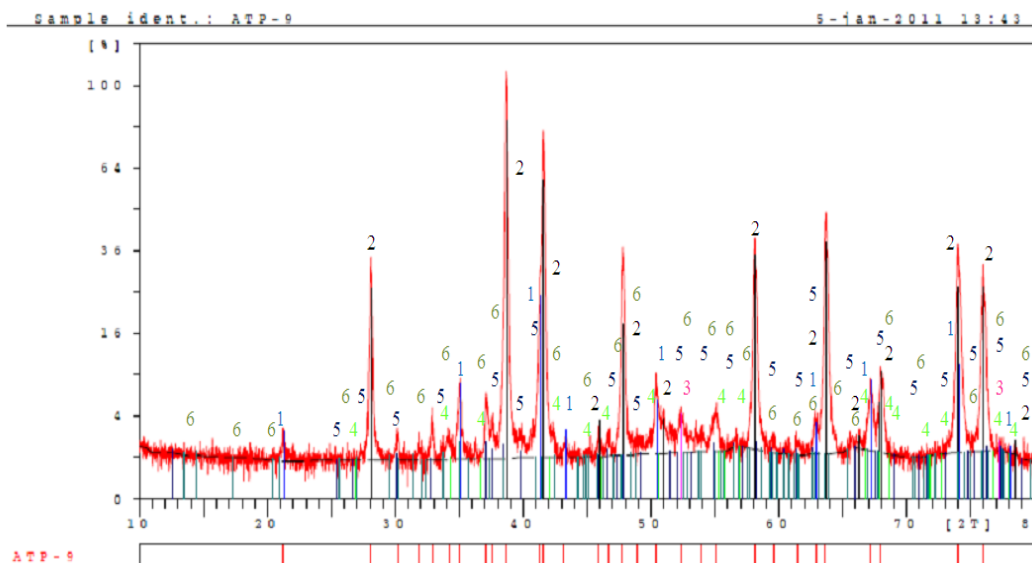
Data in table 2, including pH and chlorine ion concentration shows a great difference with the ones proposed in boiler maintenance manual. In other word, lack of control on feed water and wastewater quality was confirmed as main cause of corrosion in this case. Scales of steam drum were collected and subjected to analysis too. Results of qualitative analysis and XRD micrograph of these scales are given in table 3 and fig 9, respectively

Figure 9: XRD graph of steam drum scales
