# A Case Study on Causes of Scale Formation- Induced Damage in Boiler Tubes

Alireza Bozorgian\* and Mehrdad Ghazinezhad

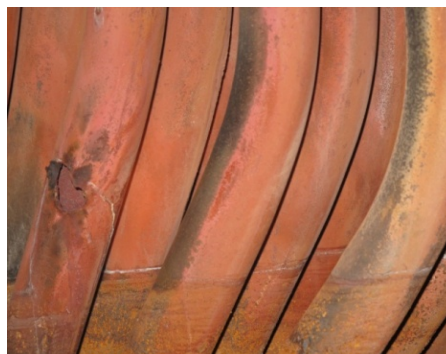
Inspection of boiler showed that one of boiler tubes has been damaged approximately 30 cm upper than its bottom, caused by corrosion of inner surface (Figure 1).

Figure 1: Tube damage

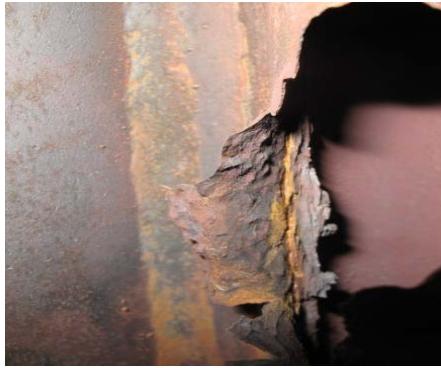
Inner surface corrosion induced deterioration and thinning of this tube is shown in figure 2. It is clear that the corrosion reduced the tube thickness. Then this tube eventually ruptured because of lack in pressure strength.

**Figure 2:** Tube damage at higher resolution

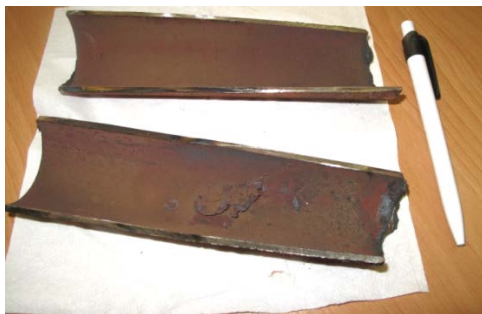
As it is seen in figure 3, gradual and zonal scale formation and corrosion is observed in tube side, which is exposed to fire. These are hard, sticky and dark brown colored scales. The amount of these scales is considerably high in area of 30-50 cm over mud drum, which is exposed to hot gases. The occurrence of corrosion is obvious under these scales.

**Figure 3:** Unholed tubes

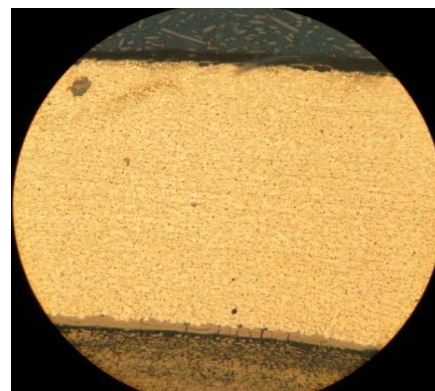
In order to investigate the morphology of scales and changes in microstructure of tube surface in corroded area, sample with hard sticky scale was selected and subjected to optical and scanning electron microscopy after appropriate preparation. SEM study presents that the outer surface of tube has no protective oxide coating, but the inner surface possesses a thin oxide layer and a porous scale (Fig. 4). As is depicted in fig.4, several cracks are present in oxide layer, which may lead to lack of adhesion of this layer to tube surface and hence, the lack of protection against corrosion. Because of porosity of scales and cracked character of oxide layer, corrosives diffuse into these layers and facilitate the surface corrosion of tube surface.

**Figure 4:** Cracked porous oxide layer of scale on inner tube surface

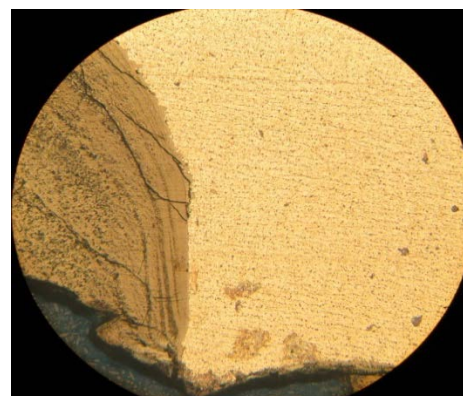
The presence of a protecting layer of scales in the inner surface of tube is shown in figure 5, which has been taken from zone located approximately 10 cm away from damaged zone. This layer possesses several cracks. Corrosives in association with water diffuse into layer of scales through these cracks. This phenomenon promotes the zonal corrosion.

**Figure 5:** Numerous cracks and diffusion of corrosives into the protective layer of scale on inner tube surface

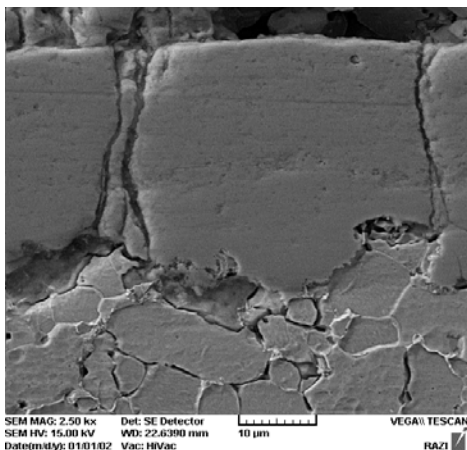
Fig 6 shows the tube cross section in damaged area. It is observed that oxide layer is cracked in several zones. As it was mentioned

earlier, the presence of these cracks facilitates the diffusion of corrosives into the surface of tube surface.

corrosives from inner surface of tubes through these cracks to interface of oxide layer and tube surface causes corrosion.

**Figure 6:** Corrosion initiation at the interface of protective layer and tube surface at the end of protective layer

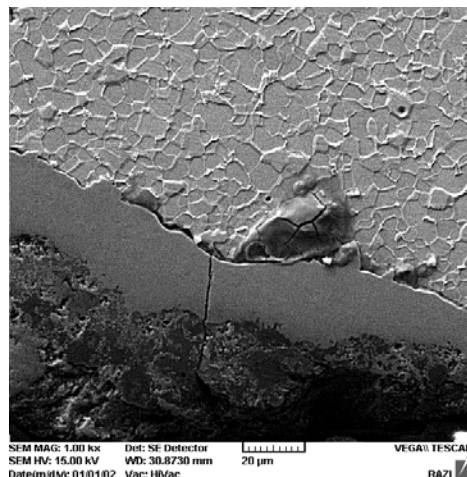
**Figure 7:** Tube cross section of the tube and crack in damaged zone

The onset of corrosion at the interface of protecting layer and surface of tube surface is shown with higher magnification in figure 7. It is clear that the corrosion initiates at the crack tips of protective layer, which act as directing channels for corrosives to the tube surfaces. As it is shown in figures 6 and 7, diffusion of

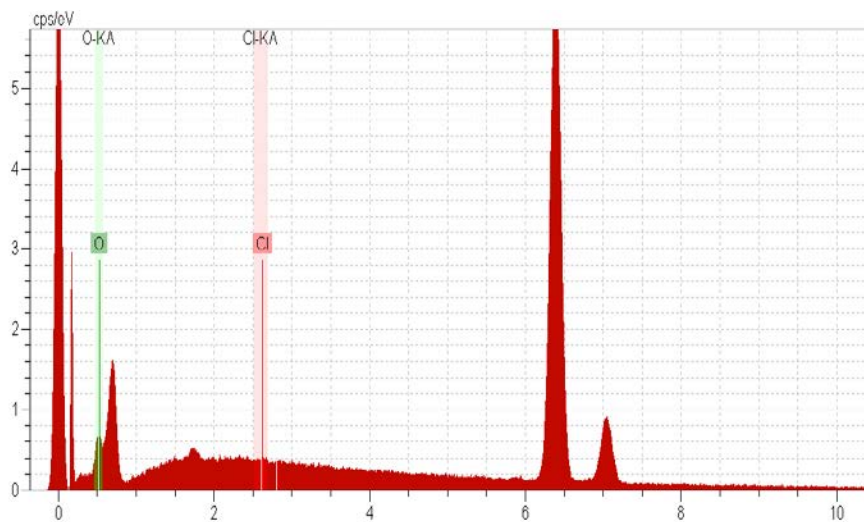
Chlorine map and corrosion germination under protecting layer is depicted in figure 8. This map clearly suggests chlorine ions aggregation in crack tips and interface between metal and oxide layer which causes corrosion germination in this zone.

**Figure 8:** Map of elemental chlorine and oxygen

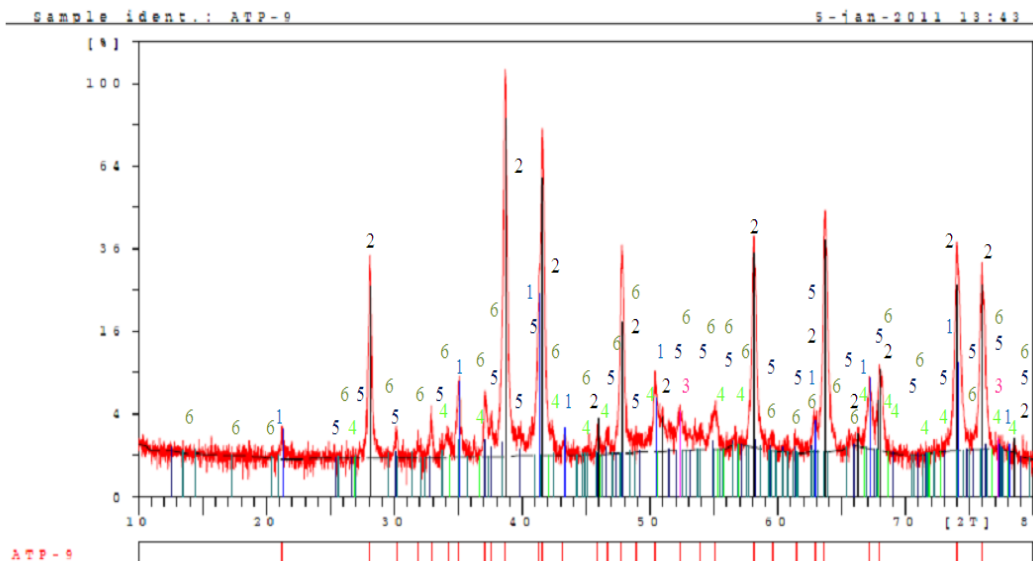
Data in table 2, including pH and chlorine ion concentration shows a great difference with the ones proposed in boiler maintenance manual. In other word, lack of control on feed water and wastewater quality was confirmed as main cause of corrosion in this case. Scales of steam drum were collected and subjected to analysis too. Results of qualitative analysis and XRD micrograph of these scales are given in table 3 and fig 9, respectively

Figure 9: XRD graph of steam drum scales
